# CP Survey Report

## ROV Survey Galvanic Anodes

Trondheim Havn dep. Verdal

Doc No. 3-P1040-101-ANA-001. Rev 01 Verdal Havn CP Survey Report

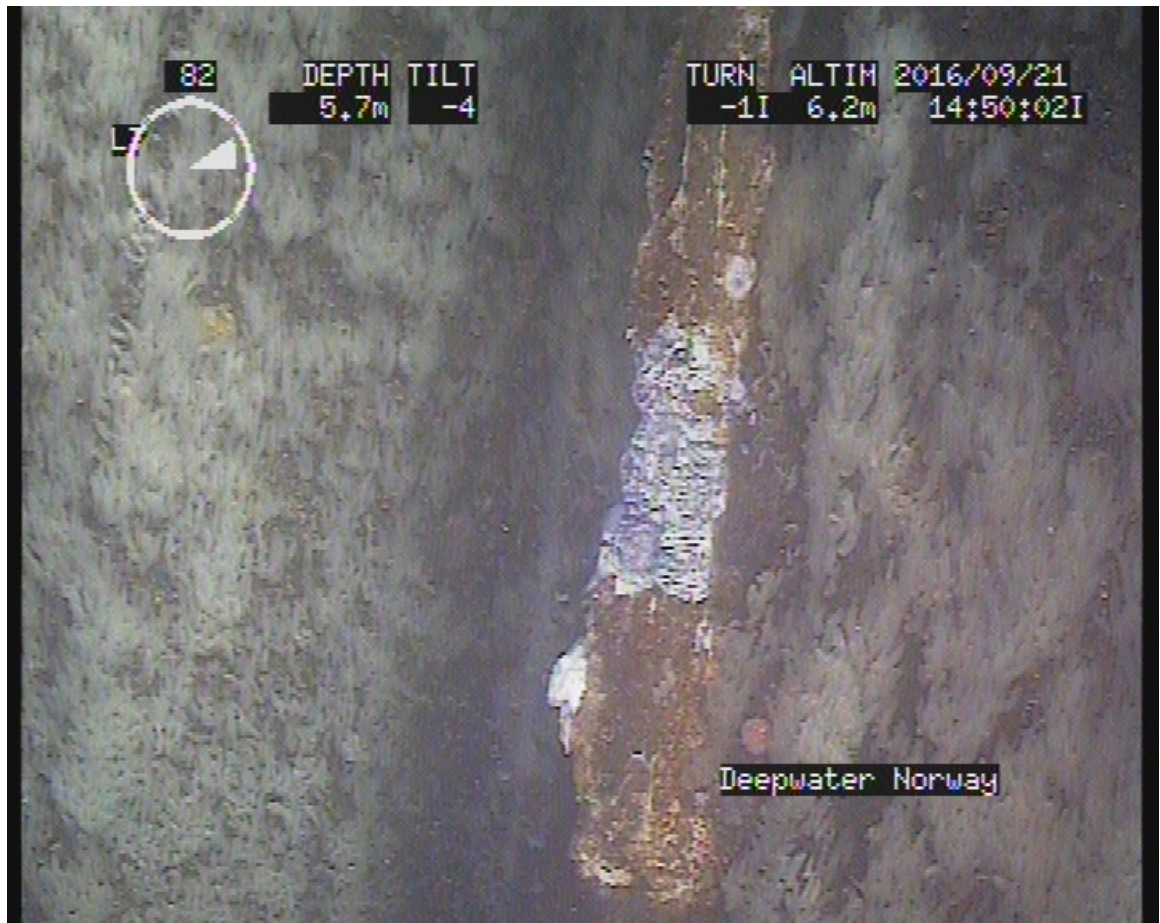
The anodes were inspected visually for mechanical damages, general evaluation of conditions and extent of marine growth. The visual inspection reveal that the sheet piles and anodes are covered by marine growth. Apparently, the steel is covered mostly by softer marine growth, but seems intact with no wear or damages. It was, however noted that a ladder dropped and was left hanging on the cell piles. The anodes are covered with harder marine growth, see pictures below.

Figure 6-1 Picture showing sheet piles with marine growth and anode with cleaned section

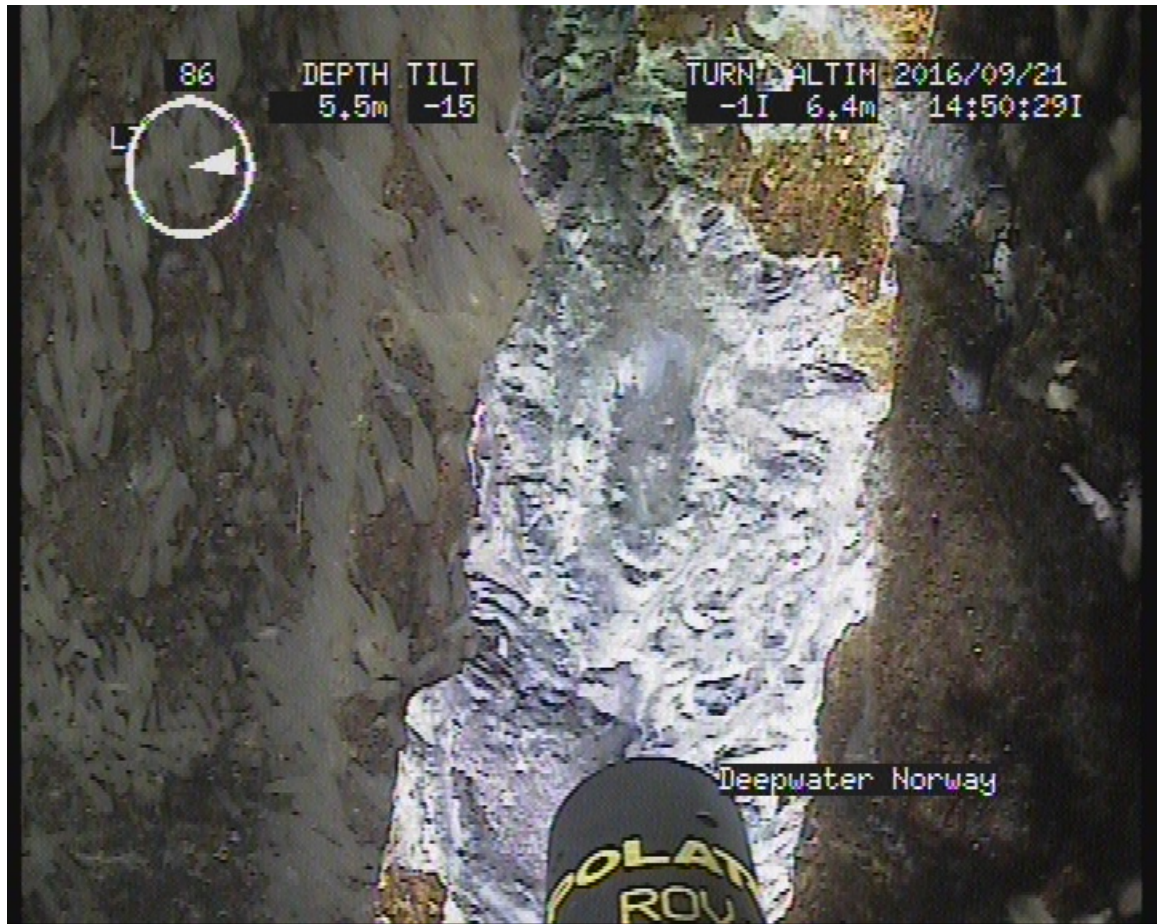
Figure 6-2 Picture of cleaned anode showing large pits and hard marine growth outside the jetted area

Six (6) of sixteen (16) anodes were measured to 35-40% consumption. From the inspection videos (sent separately on e-mail) one can see that marine growth is significant and is hiding most of the anode surfaces, but one can see larger pits and some uneven consumption on the anodes (see also Figure 6-1 and Figure 6-2). Hence, as a conservative approach evaluation of remaining life in the sections below are based on 40% consumption over 9 years.

The hard marine growth on the anodes may be a source of error when evaluating anode consumption. Hence, one should evaluate to brush the anodes before next measurement.

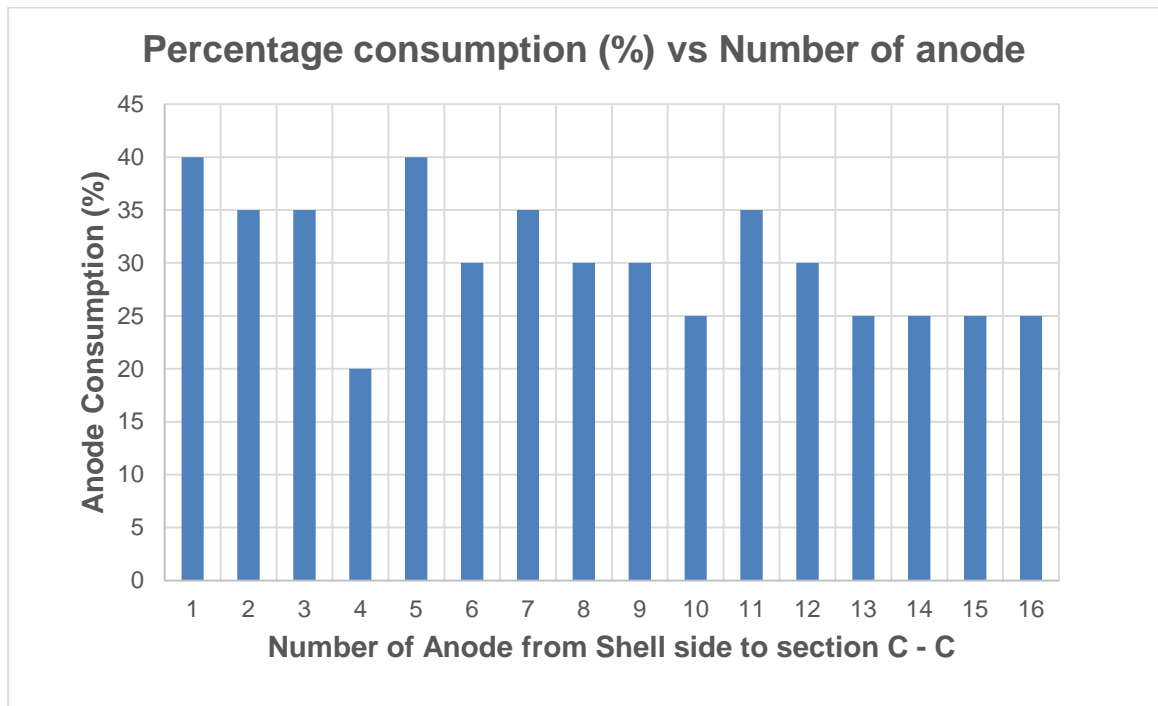
**Figure 6-4: Graph showing measured anode consumption**

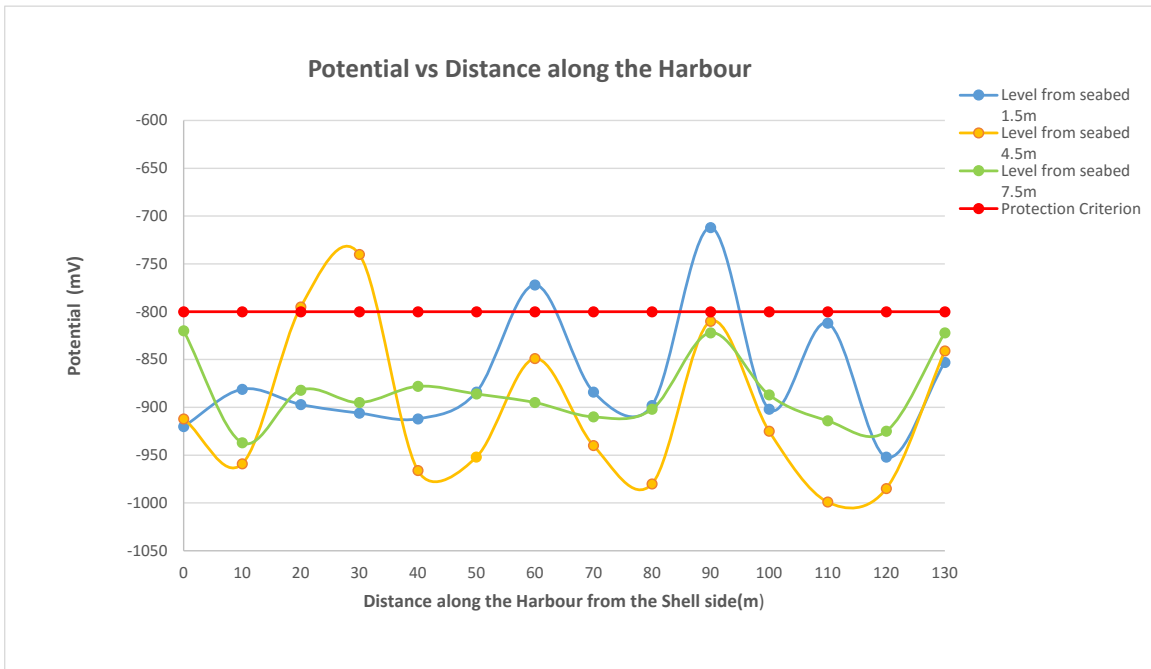
**Figure 6-5: Graph showing structure potential readings along the harbour.**

From the forty two (42) contact measurements, four (4) show potential more positive than the -800 mV protection criterion. These may be a result of poor contact between the probe contact tip and the steel due to marine growth, some passivation tendency of nearest anodes or tidal flow increasing during inspection.

All measurements outside the protection criterion are from -712 mV as the most positive to -795 mV as the most negative. None of the four potential values gives a risk of corrosion, but will be monitored closely during the next inspection.
